Construction at Cloud Level

Building a Radio Communications Facility in Alaska

To build a new radio communications facility on a “high site” in Alaska’s Tebenkof Bay Wilderness Area, an innovative design approach avoided the need to cast foundations onsite under difficult conditions and helped reduce the field schedule by at least 60 percent.

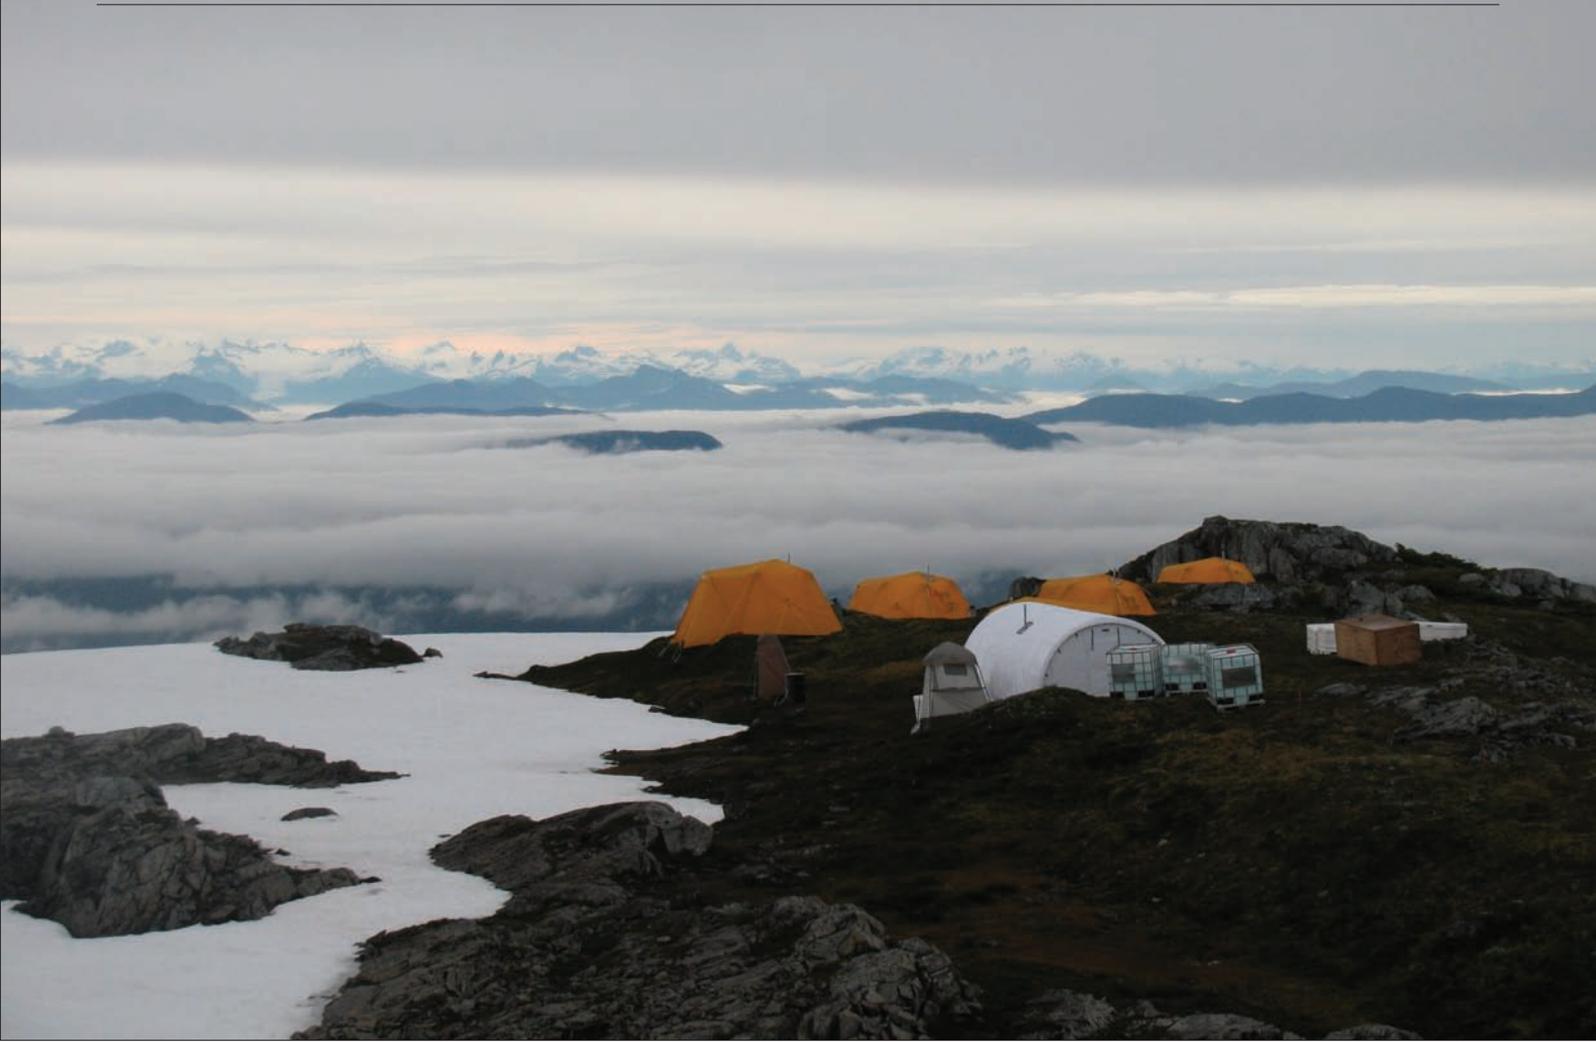
Field work to build a new Federal Aviation Administration Self-Sustained Outlet radio communications facility on Alaska's Kuiu Island was completed in nine days. Crew remained onsite in camp with full life support. PHOTOS COURTESY AHTNA ENVIRONMENTAL

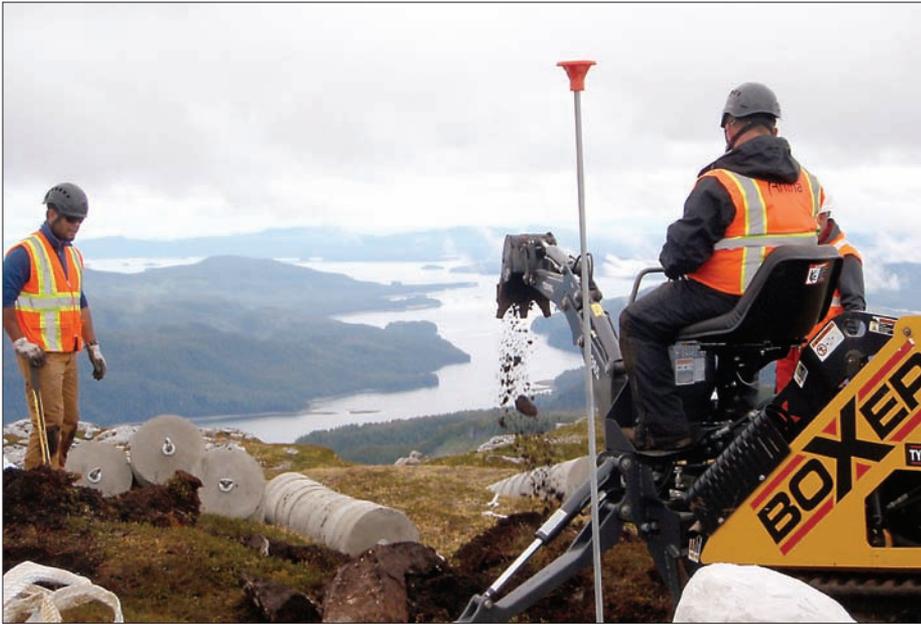
The only piece of hydraulic equipment mobilized to the site was a mini-excavator.

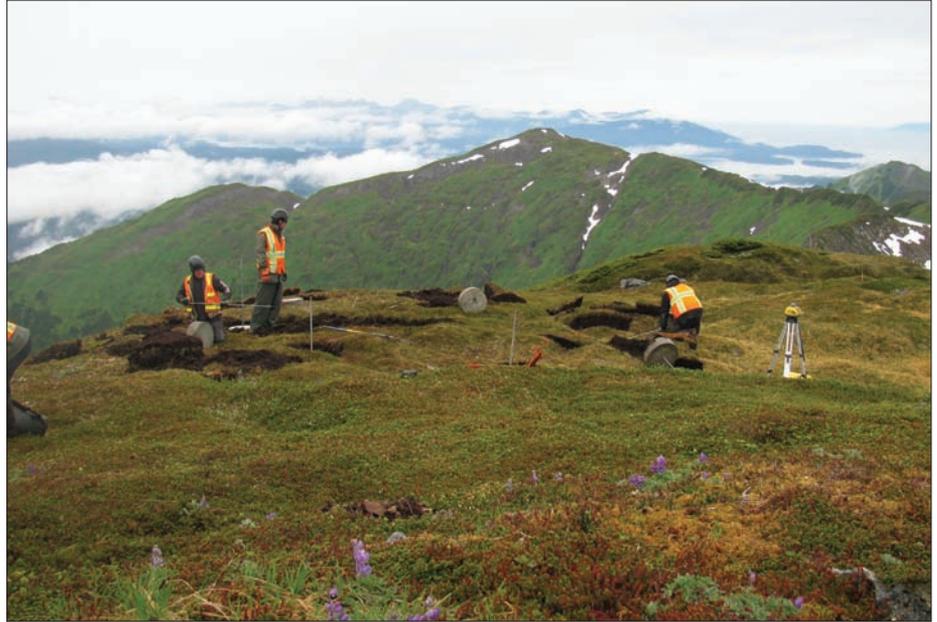
Excavation to prepare the site for placing a series of concrete disks that formed the structure's foundation was primarily performed by hand due to the uneven terrain.

The work area was approximately 180-ft by 50-ft in size, with varying elevations (as much as 30-ft of change in elevation across the site). The team laid out the site per the plans with the exception of the new helipad, which was established in a different location due to grade variations. Excavation followed primarily by hand due to the uneven terrain and risk of overturning the excavator. A total of 16 holes were excavated between 1-ft and 3-ft deep down to bedrock. Rock anchors were installed using epoxy to resist the uplift and overturning forces caused by extreme mountain top weather.

After the epoxy cured overnight, the team placed the precast concrete foundations, manually moving each disk one on top of the other within the excavation until reaching soil elevation, without the need for heavy equipment.
