Nine Days in California

A Complex Remediation at Military Ocean Terminal Concord

What began as a 60-day window to perform the second phase of a complex remediation at Military Ocean Terminal Concord was significantly compressed by mission and weather constraints, yet undaunted, the project team completed the work in just nine days.

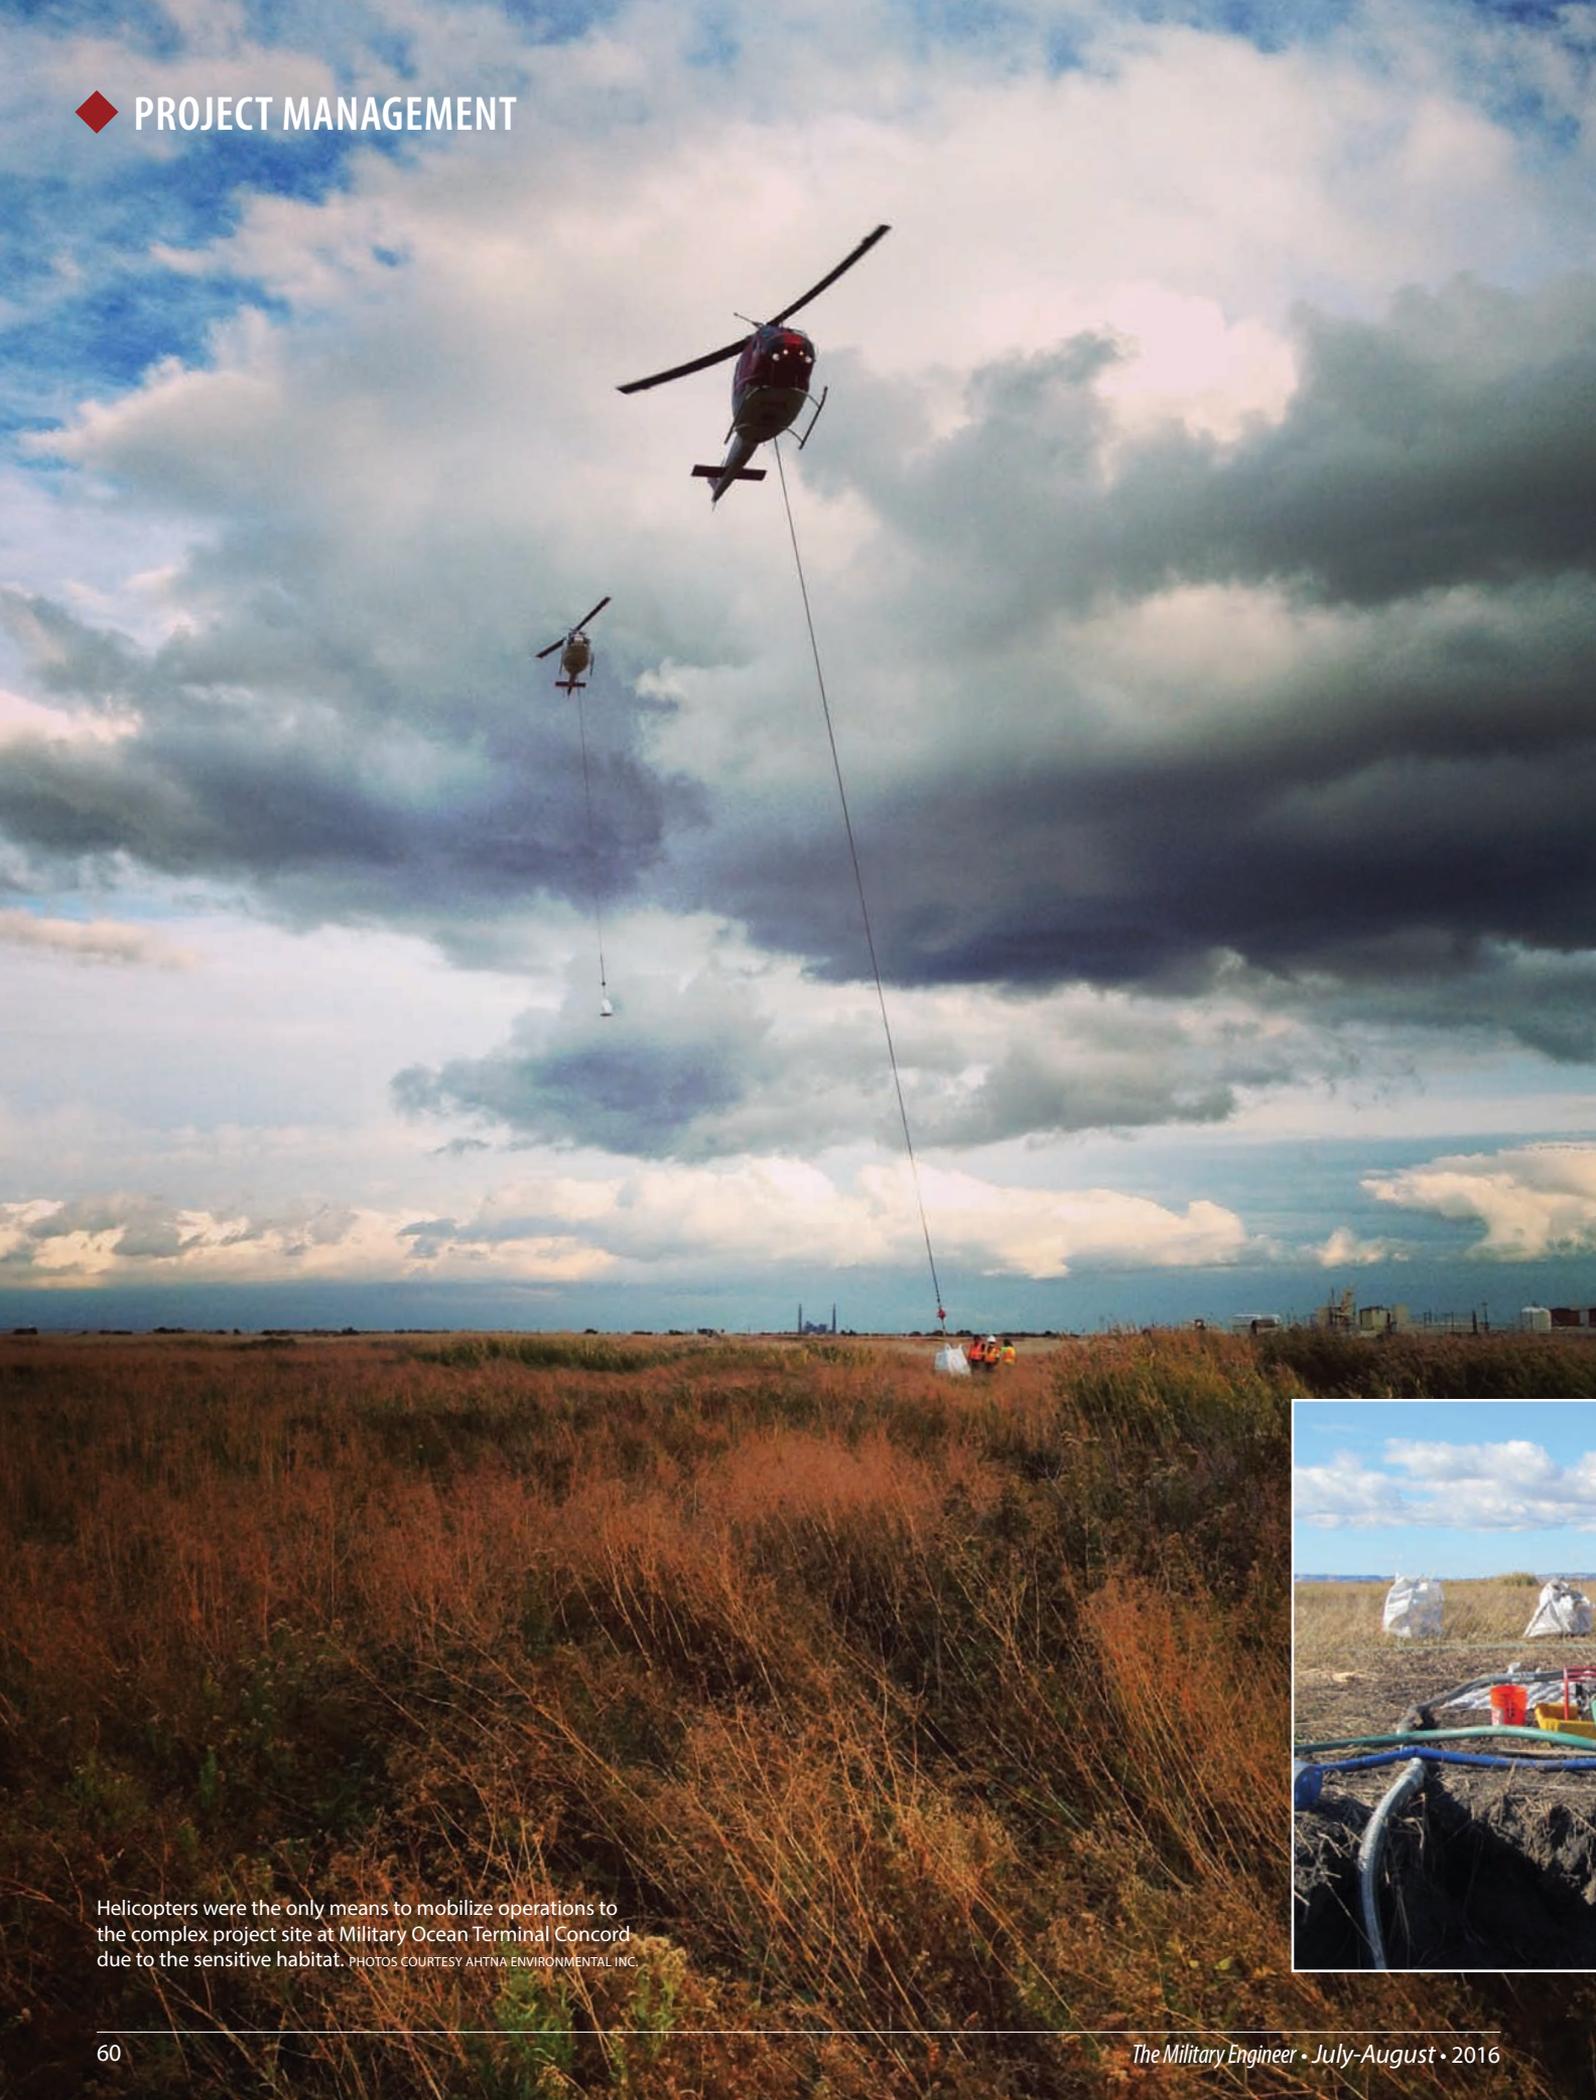
Helicopters were the only means to mobilize operations to the complex project site at Military Ocean Terminal Concord due to the sensitive habitat. PHOTOS COURTESY AHTNA ENVIRONMENTAL INC.

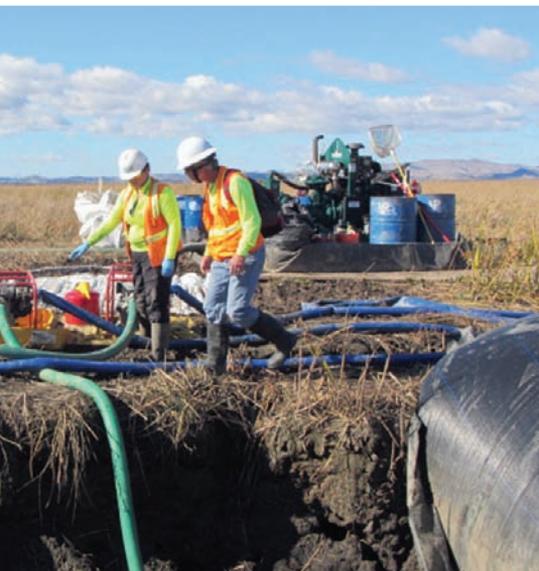
Constant dewatering operations on the project were completed using a series of pumps.

Despite the detailed plans, once operations commenced at Site 33, the main slough was not dewatering as expected—again putting the project at risk. Aerial surveys were immediately performed to determine the source of water infiltrating the main slough. Work areas were then isolated using two additional 20,000-gal bladder dams and a series of temporary earthen dams. A dedicated team maintained constant dewatering operations. Within three days, 775 super sacks of cap material had been dropped and raked into place, completing the project on Nov. 13, 2015, ahead of the scheduled MOTCO mission by 17 days—and 48 days before the initially approved deadline.

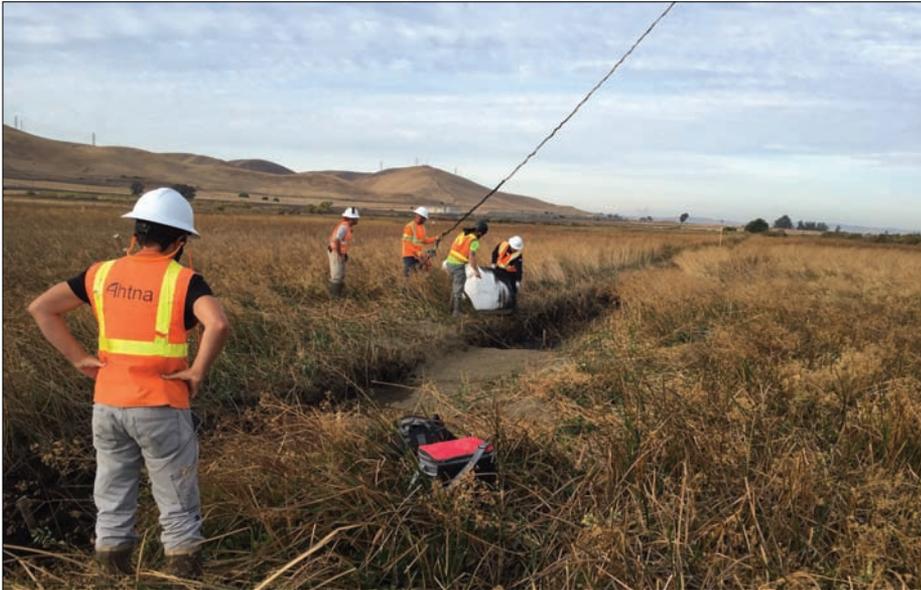
The field team placed a total of 1,700 super sacks, each filled with 2,500-lb of dried Bay Mud, to create the in situ soil caps on Sites 32 and 33.

Prior to the Phase One placement of the in situ cap at Site 32, a biological survey and unexploded ordnance survey were performed. The caps were designed to isolate the contaminated sediments from benthic organisms and were constructed using helicopters to airlift bulk super sacks, each filled with 2,500-lb of dried Bay Mud.

The helicopter was guided by a spotter on the ground who communicated with hand signals to ensure placement of each sack on a target not much more than 1-yd². Once placed, a "boxcutter team" would cut an opening around the bottom of the sack. The helicopter then lifted the sack, allowing for controlled discharge of cap material through the opening. Following discharge of

the Bay Mud, a "raking team" leveled out the cap material to the required thickness using hand rakes while the helicopter returned to the staging area to retrieve another sack.
